**04 ARLISS PROJECT
TOHOKU UNIVERSITY TEAM**

**The Mission with
the Dual Wheeled Rover**

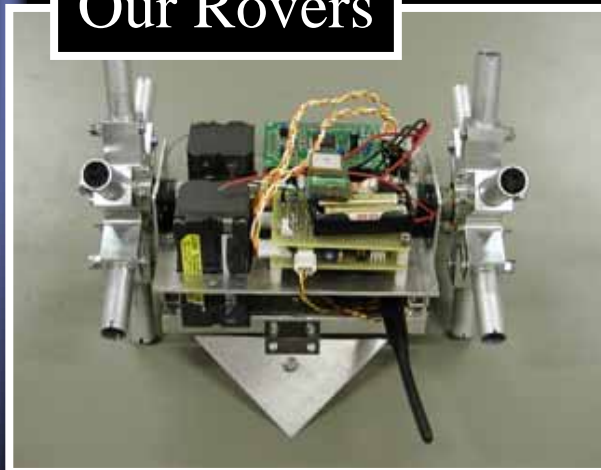
2002 : The parachute was not open and the rover was broken at landing.

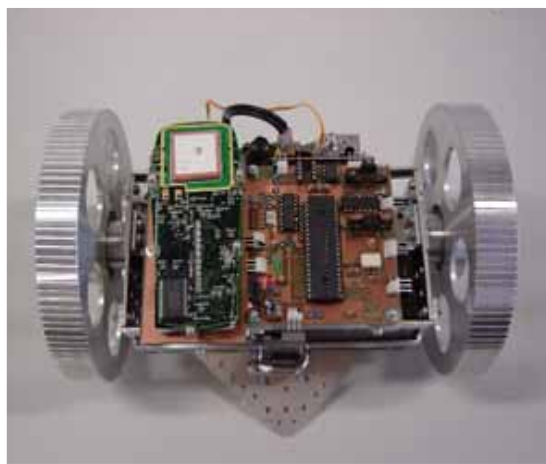
2003 : Due to the shock and vibration of the launch, the GPS receiver was suspended.

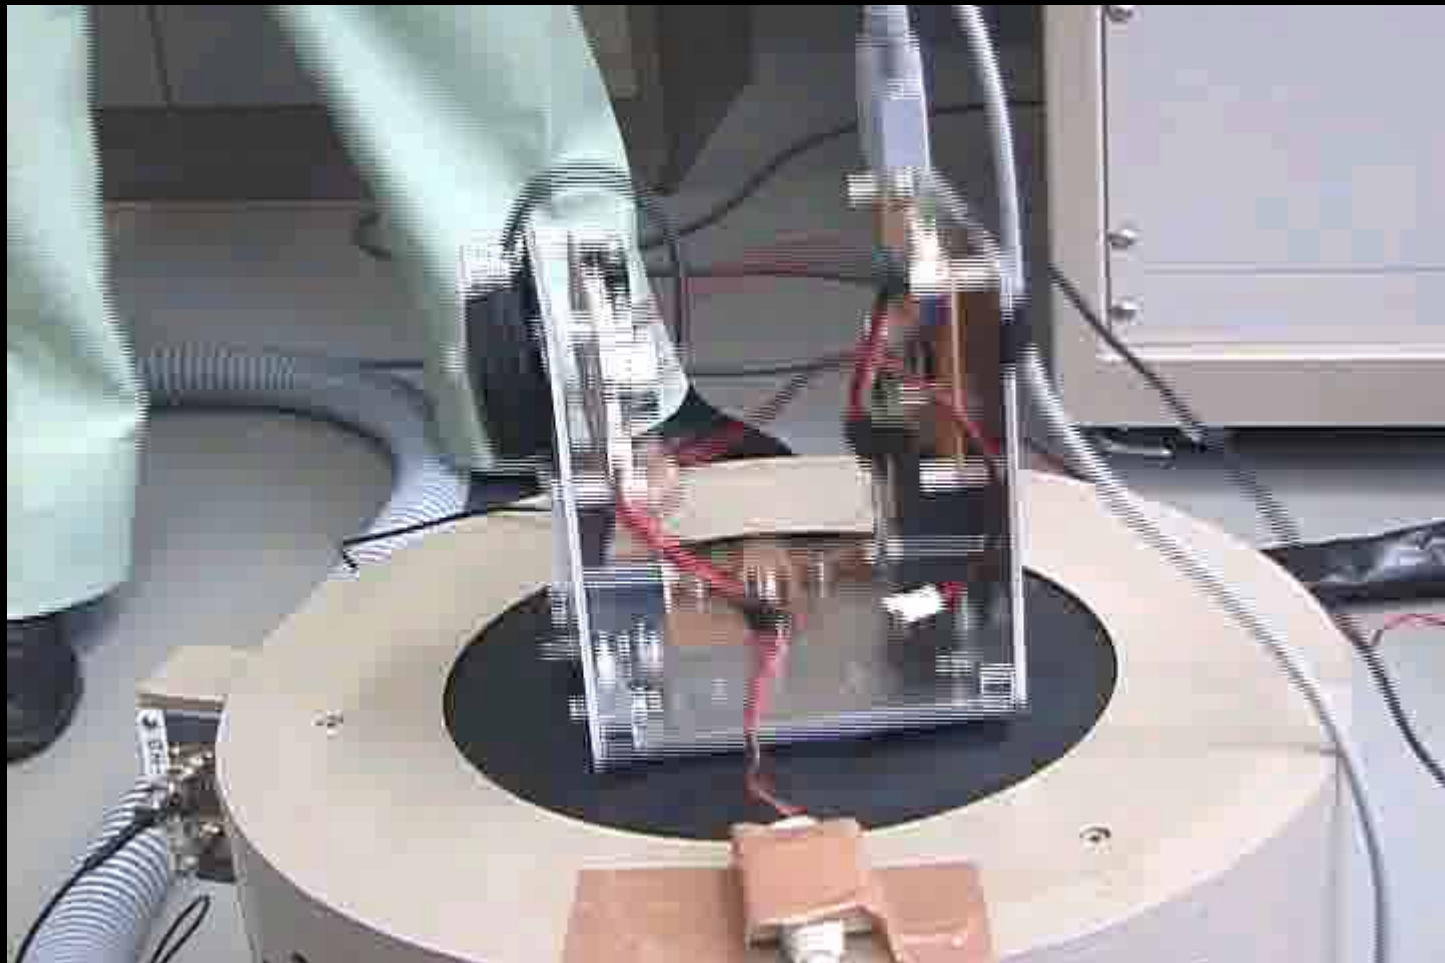
- All the electric circuit parts kept operating excellently.
- There were neither fall of parts nor a gap, etc.
- There were a disconnection of the power supply line and loosening of metal fittings.

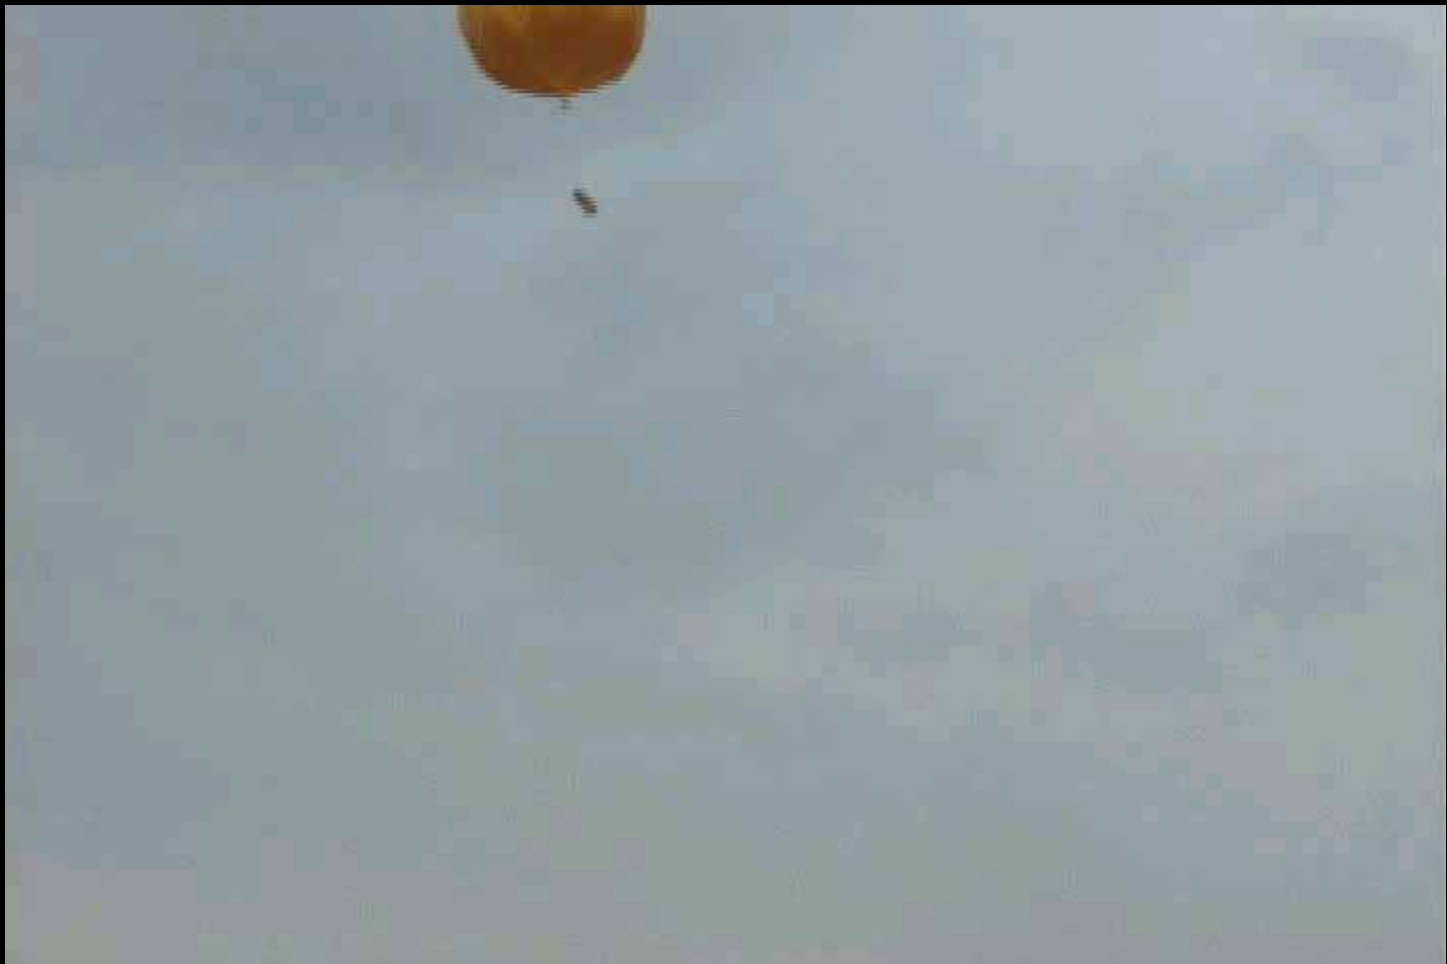
- The parachute opened both time.
- The rover didn't have damage.
- When landing, the rover splashed on ground and rolled the string of the parachute.

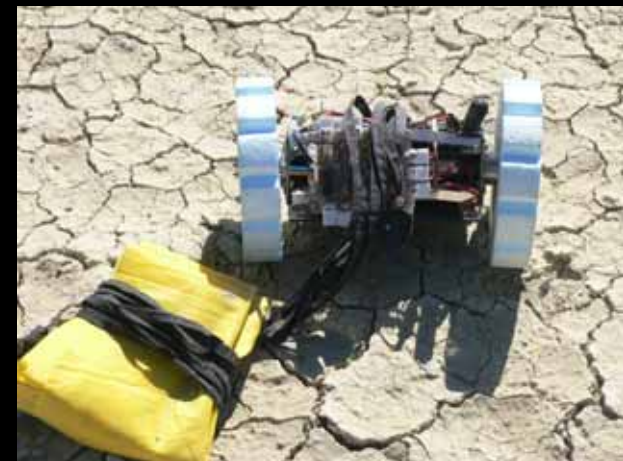
But The parachute was not open, again...

Motors was broken.

The rover couldn't move any more.
